## Honda vehicles

### Water in gas tank

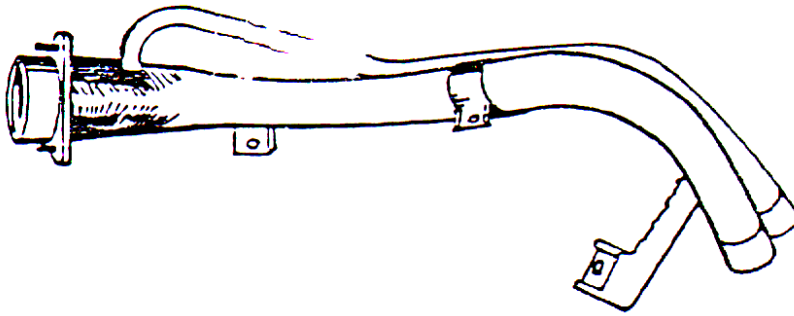
Fuel Filler Tube

Many carburetor failures for the above vehicles are caused by water contamination in the fuel bowl and the gas tank of these applications.

Our research has found the water may be entering through the fuel filler tube, which has rusted from road elements such as rocks and salt. To avoid drive-ability problems and carburetor failures, this part should be thoroughly inspected and replaced when necessary. In the event that water is found in the fuel tank the fuel must be drained and the tank cleaned.
