Part No: HLU18

**New-Gen TOYOTA HILUX 2026+**

## **HSP TAIL LOCK**

### **Fitting instructions**

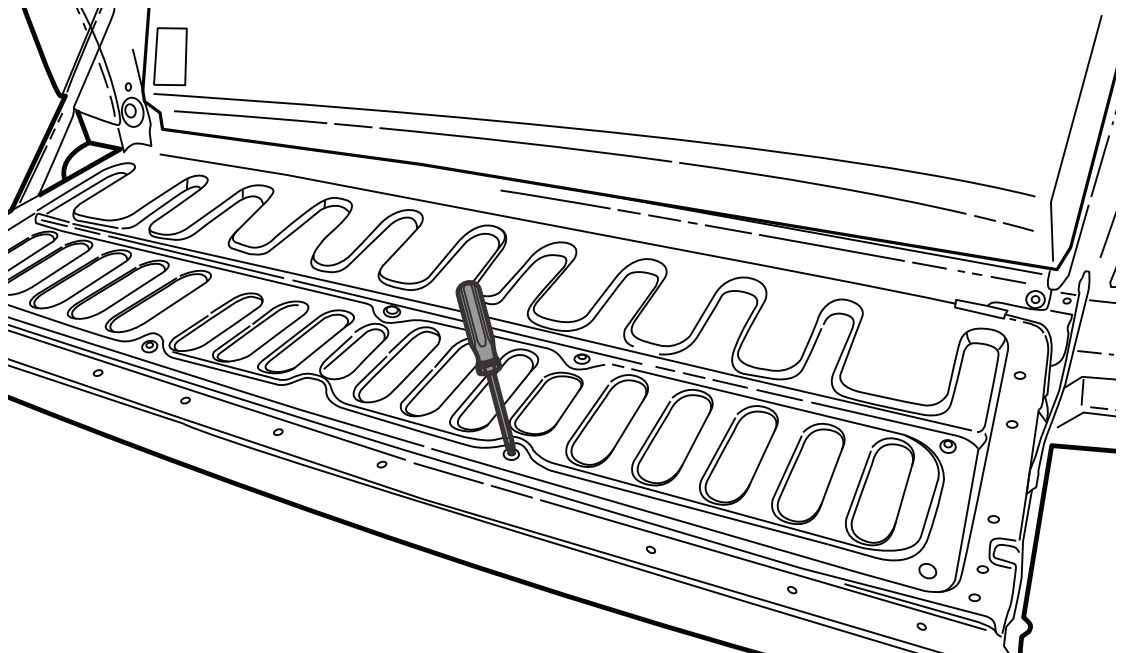
### 2 Remove the tailgate access panel and retain the cover along with all associated hardware for re-installation.

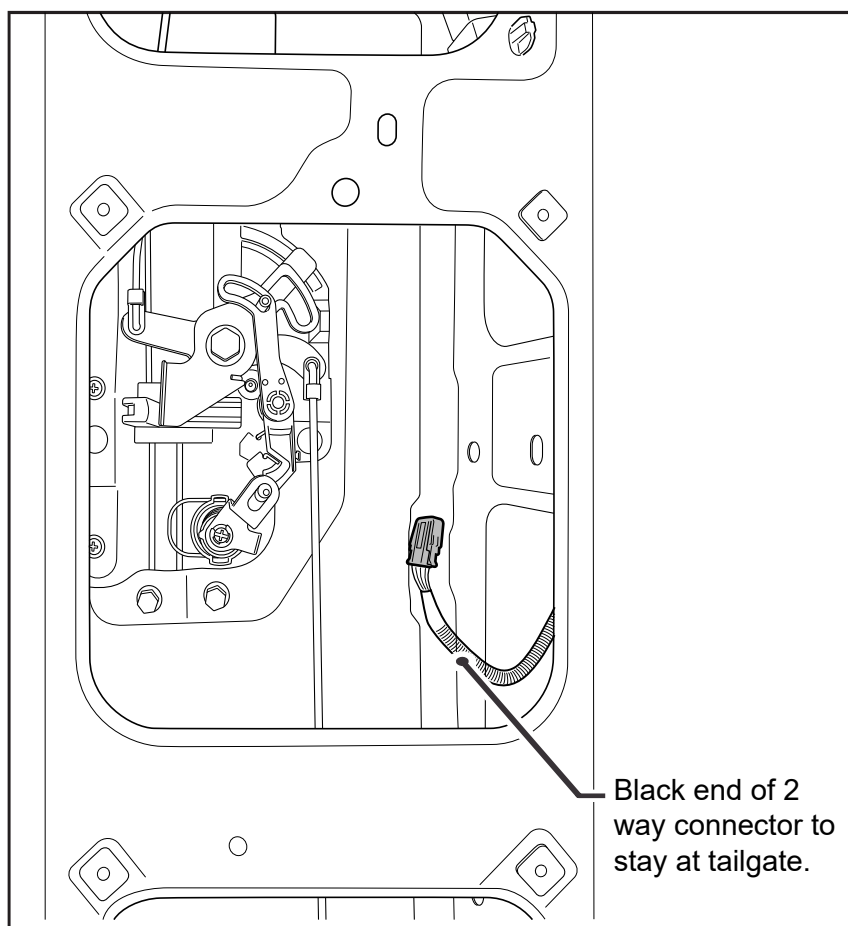
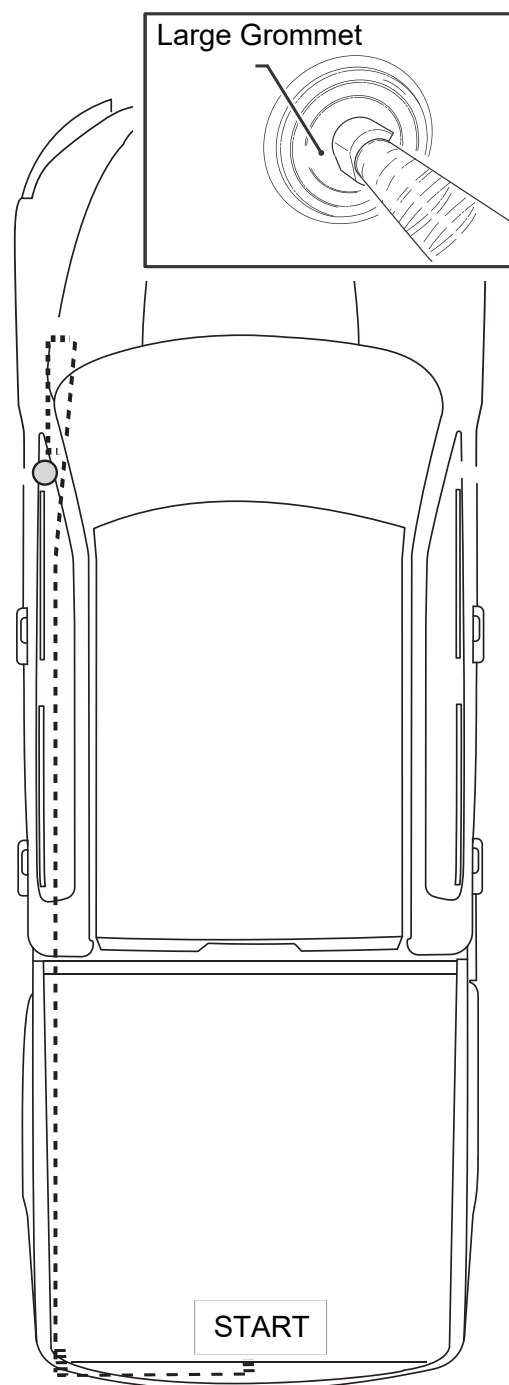
- 3 Run wiring from tailgate to front passenger side kick panel. Cable tie wiring every 500mm over chassis rail. Find the large grommet on the firewall, make a small incision & run the loom through it to enter the cab and towards the kick panel.  
**Seal accordingly.**

Black end of 2 way connector to stay at tailgate.

Large Grommet

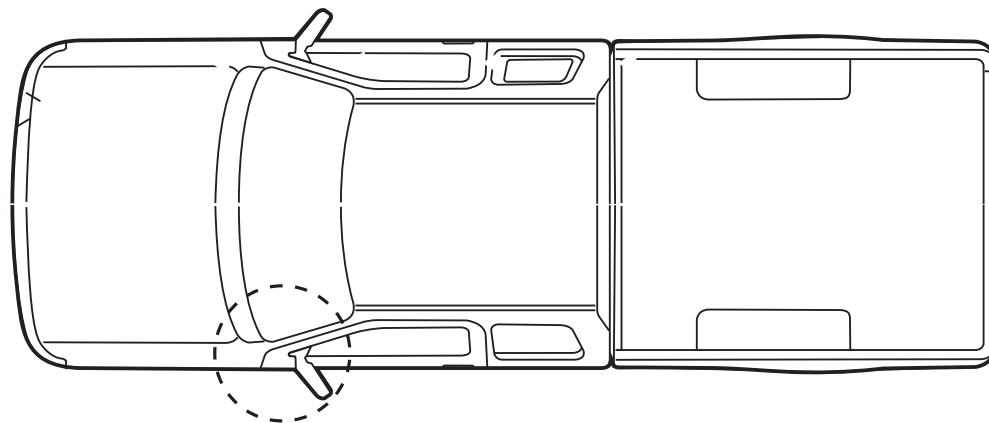
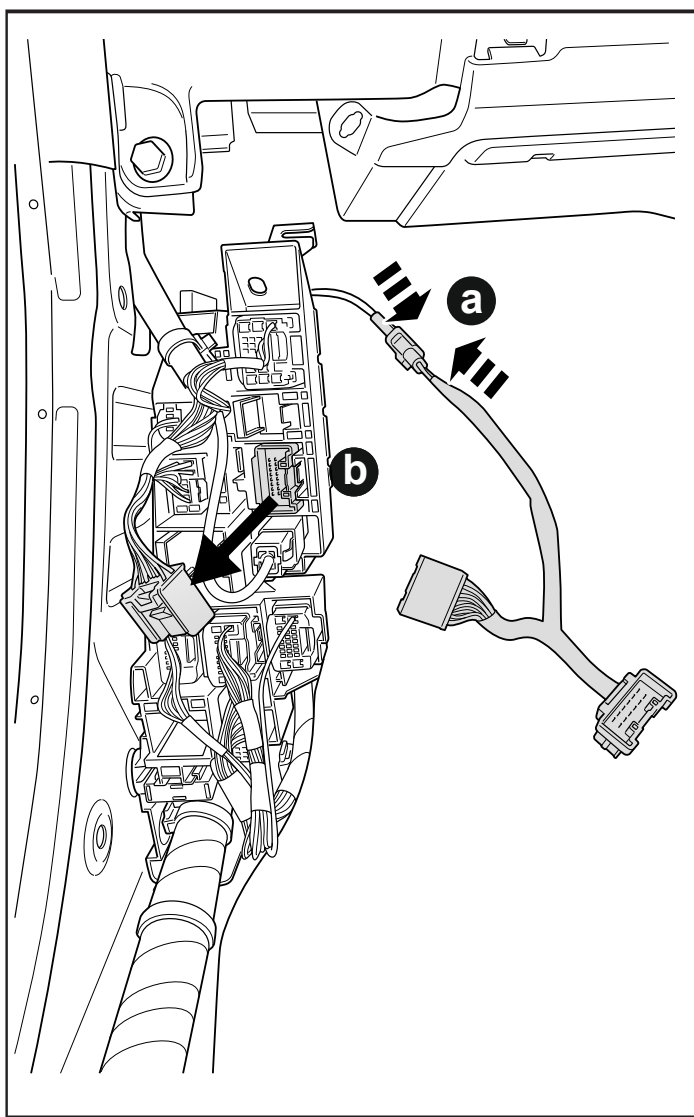
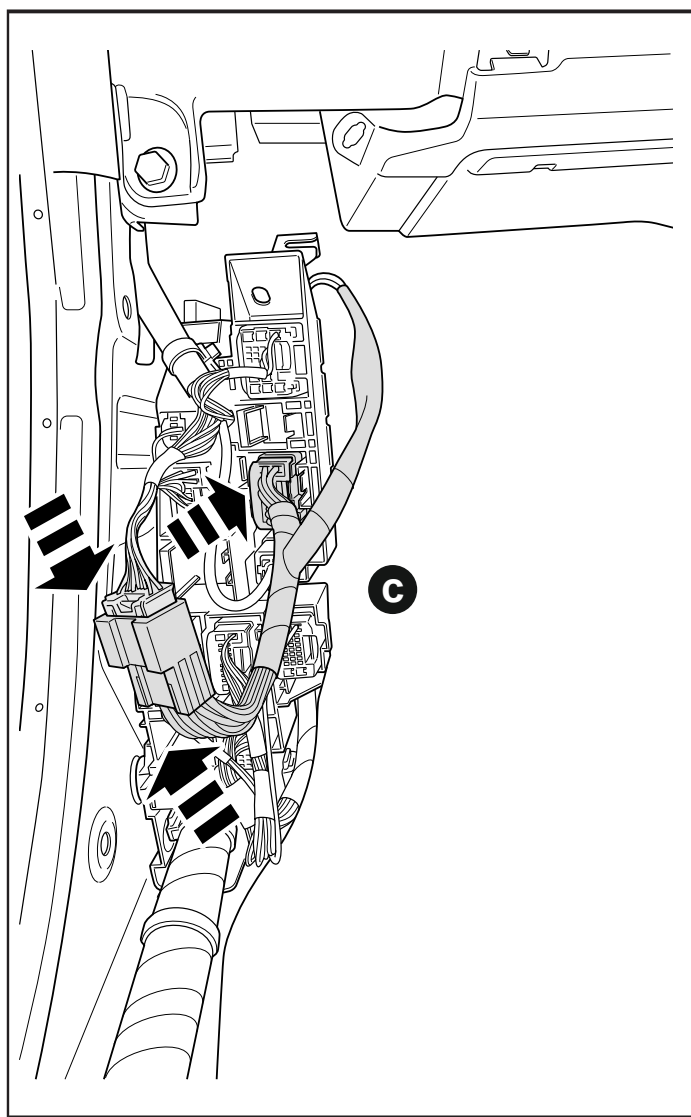
- 4 a. Connect the **H-Patch 2-way connector** to the previously routed **CL-LOOM-LONG 2-way connector**.  
b. Disconnect the indicated **20-way connector** from the vehicle harness.  
c. Connect the H-Patch inline to both the male and female ends of the harness.

Reinstall all previously removed kick panels, scuff plates, and lower glove box trim to their original positions using the retained hardware.

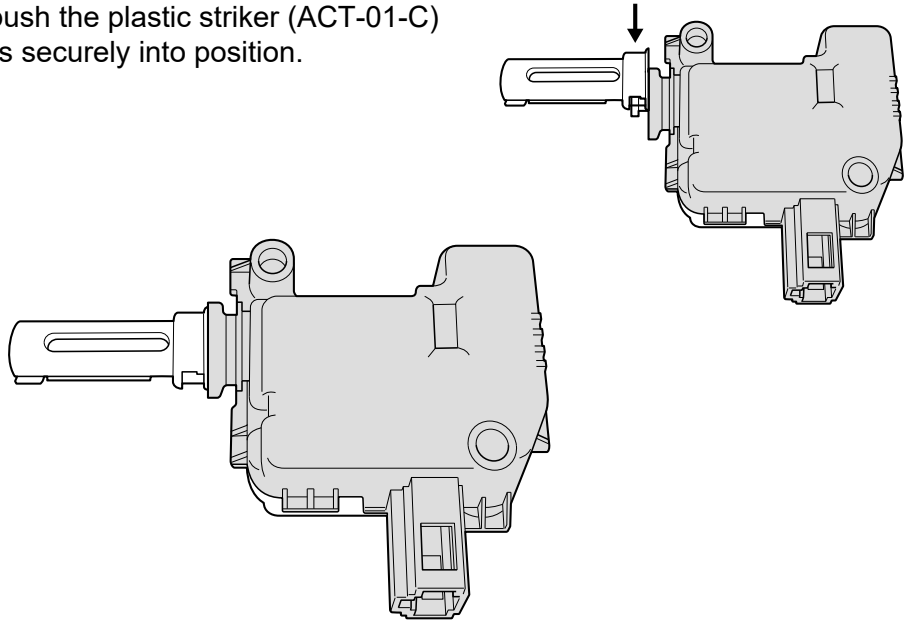
- 1 In the indicated orientation, align and push the plastic striker (ACT-01-C) onto the actuator (ACT-01) until it clicks securely into position.

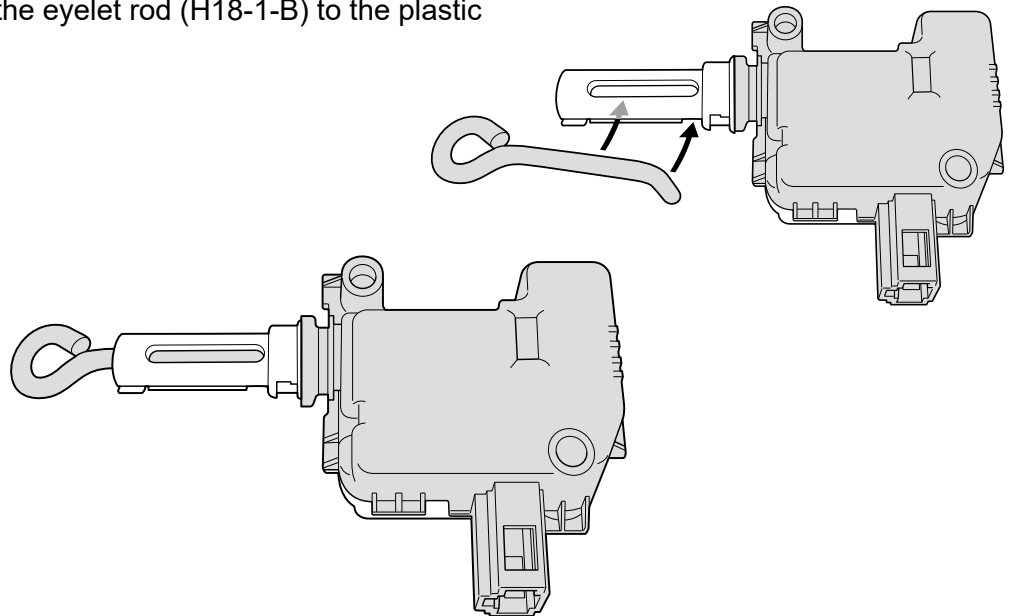
- 2 In the indicated orientation, fit the eyelet rod (H18-1-B) to the plastic striker (ACT-01-C) as shown.

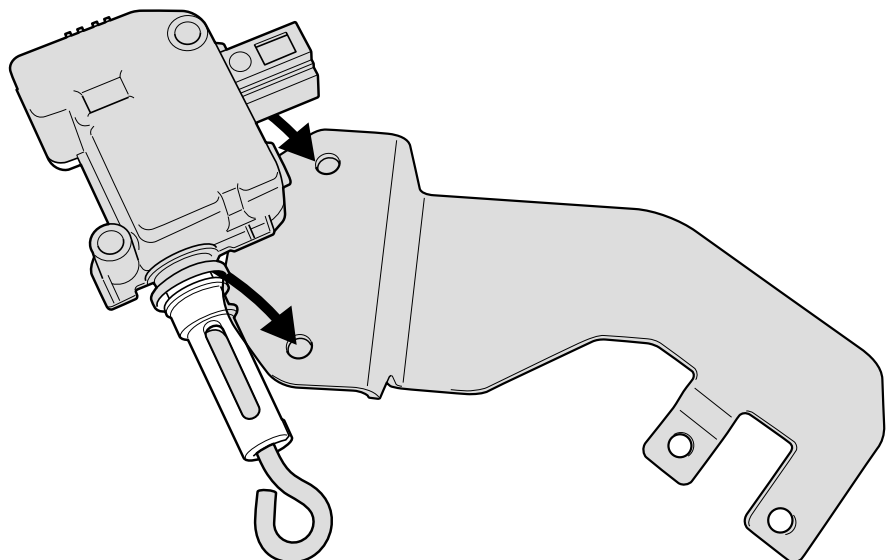
- 3 In the indicated orientation, align the actuator's mounting holes with the (HLU18-SF) bracket holes.

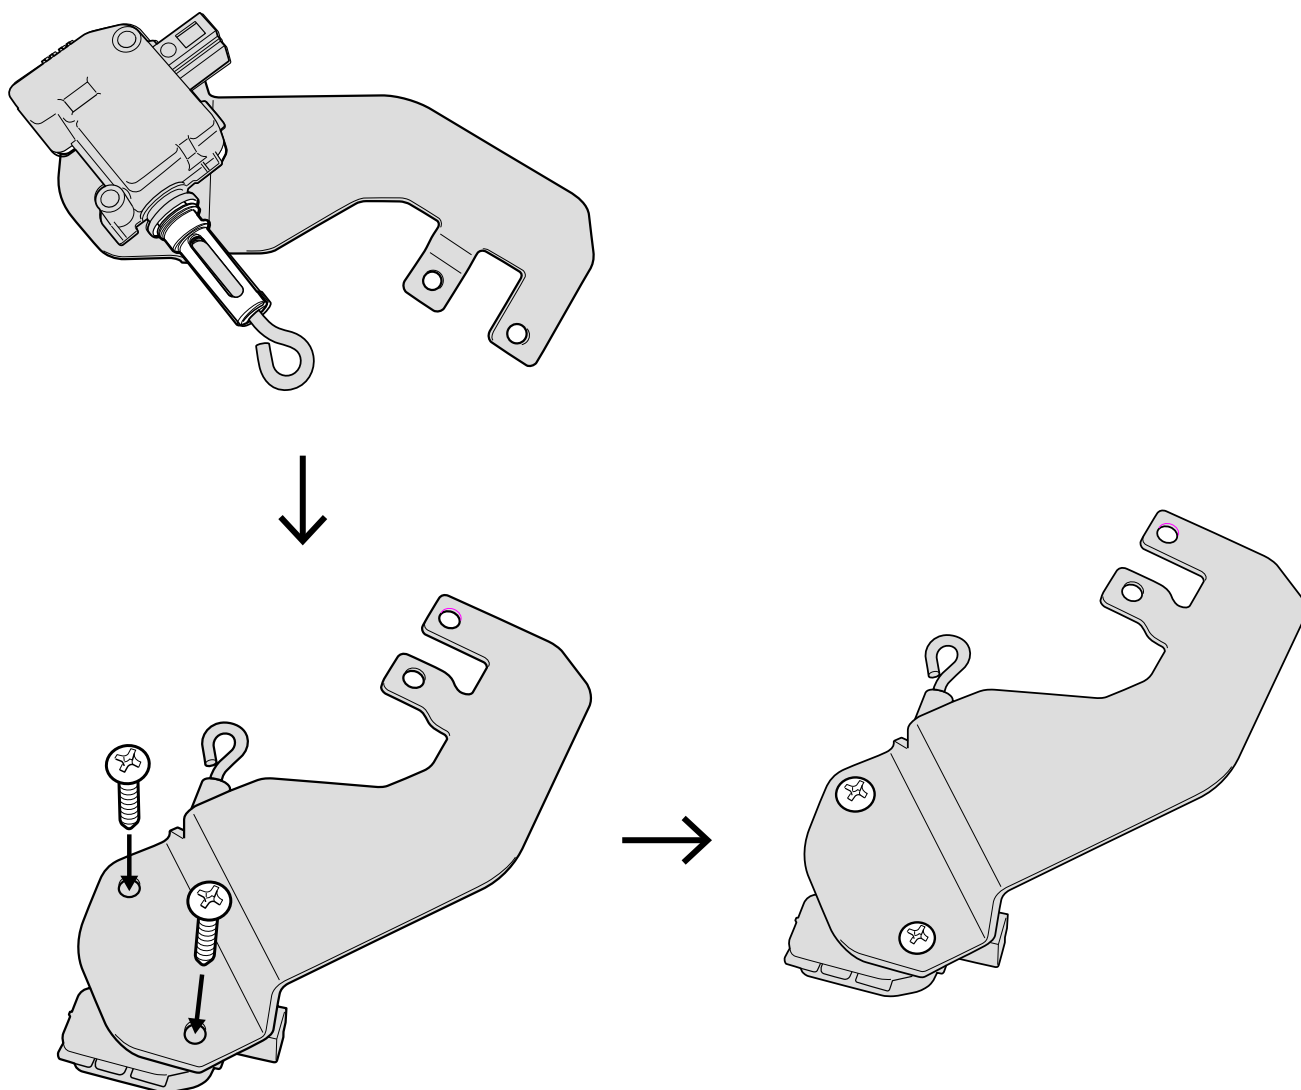
- 4 Using the supplied actuator screws (36), fasten the actuator to the TailLock bracket (HLU18-SF) as shown.

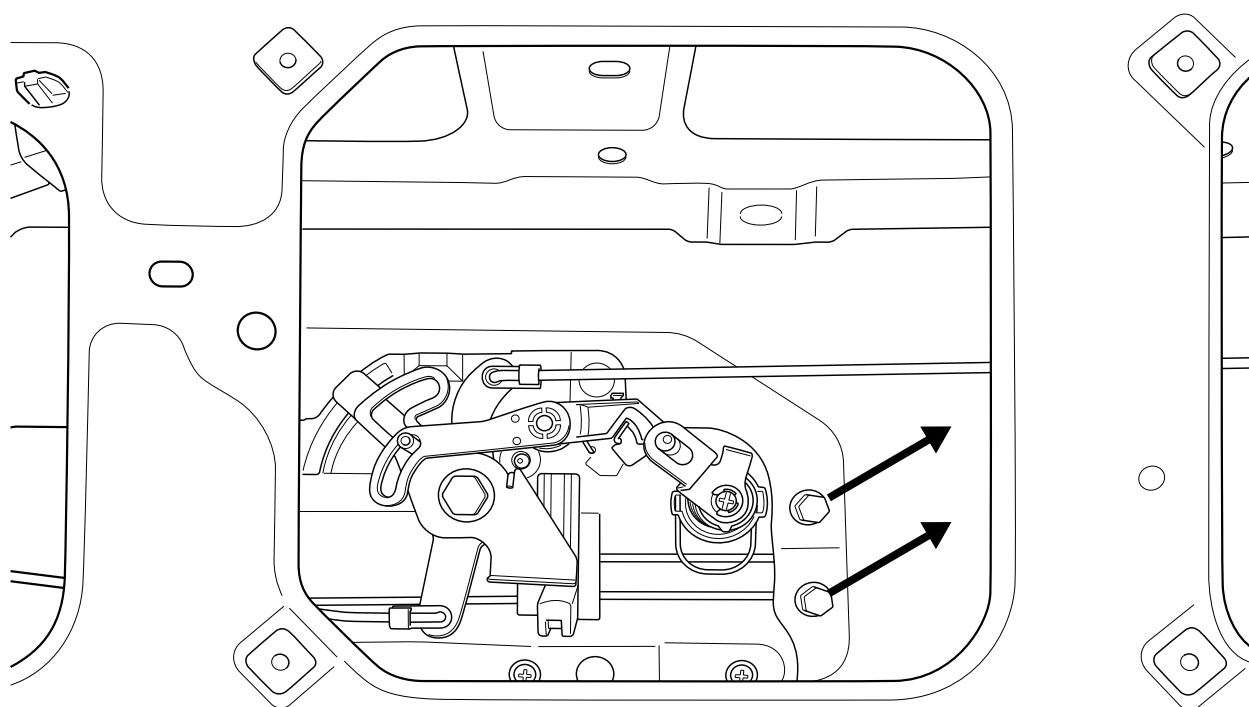
- 5 Unfasten the two indicated factory M6 bolts inside the tailgate cavity and retain them for re-installation.

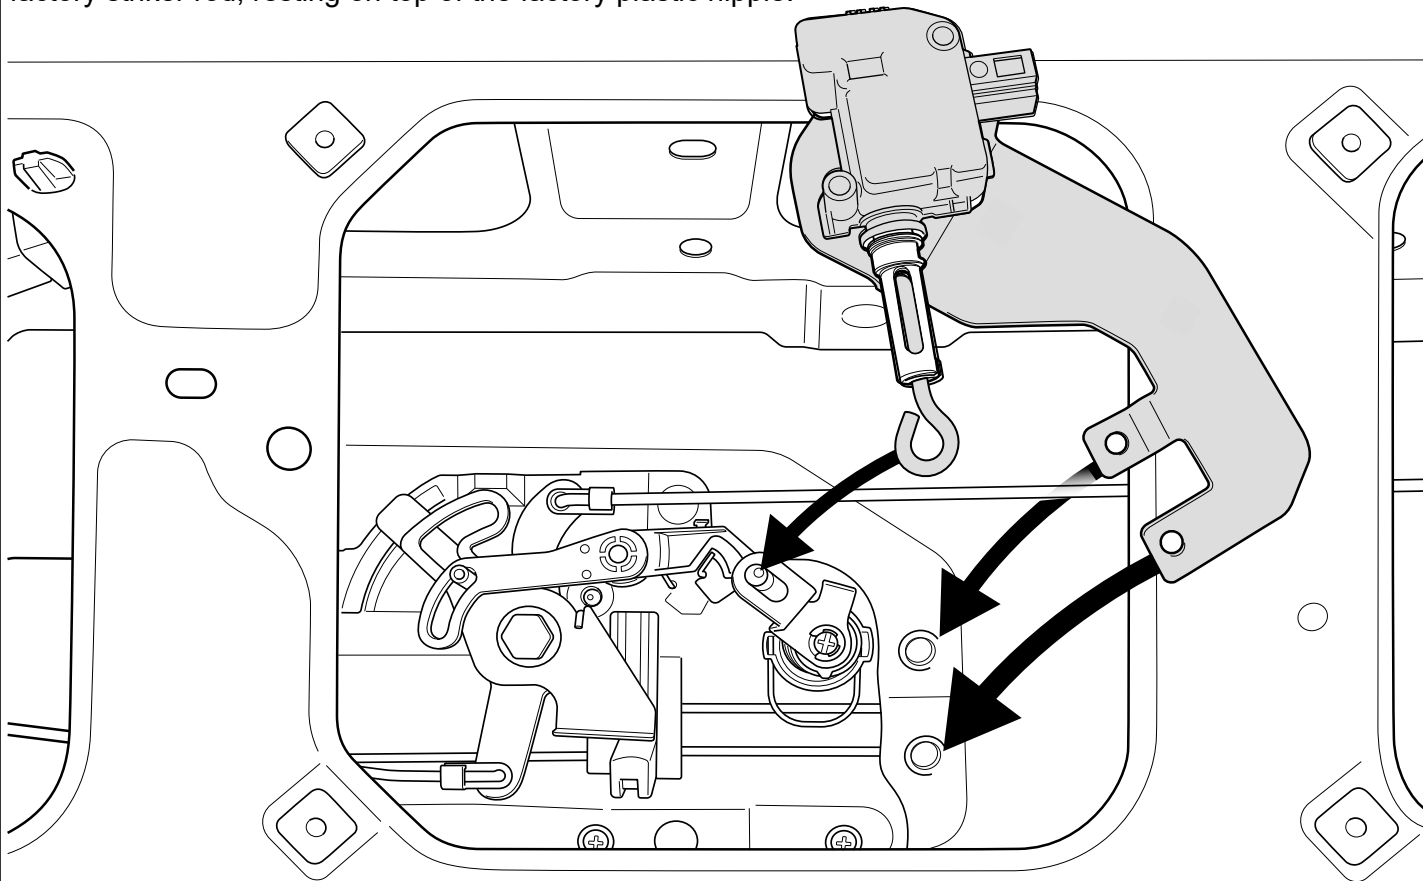
- 6 Using the assembled bracket, align it with the two threaded holes of the previously removed factory bolts.

**Note:** The bracket must sit between the factory striker rod, and the actuator eyelet rod must pass over the factory striker rod, resting on top of the factory plastic nipple.

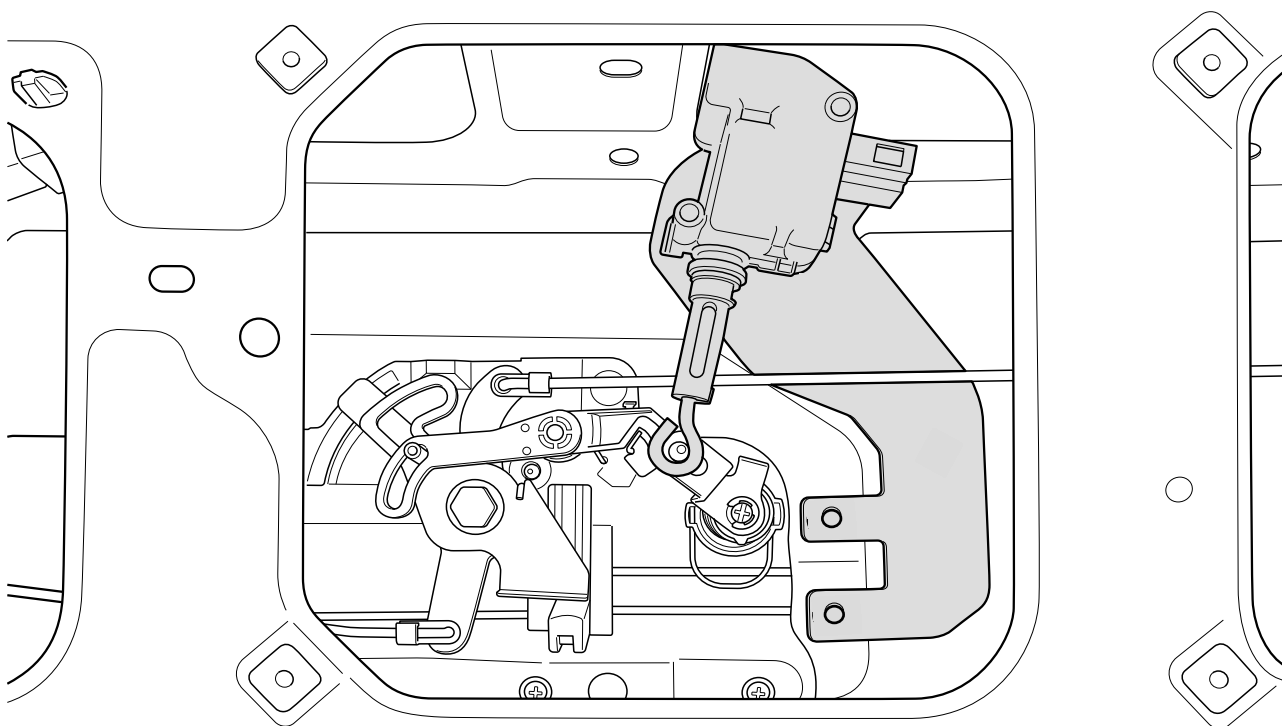
- 7 In-place view.

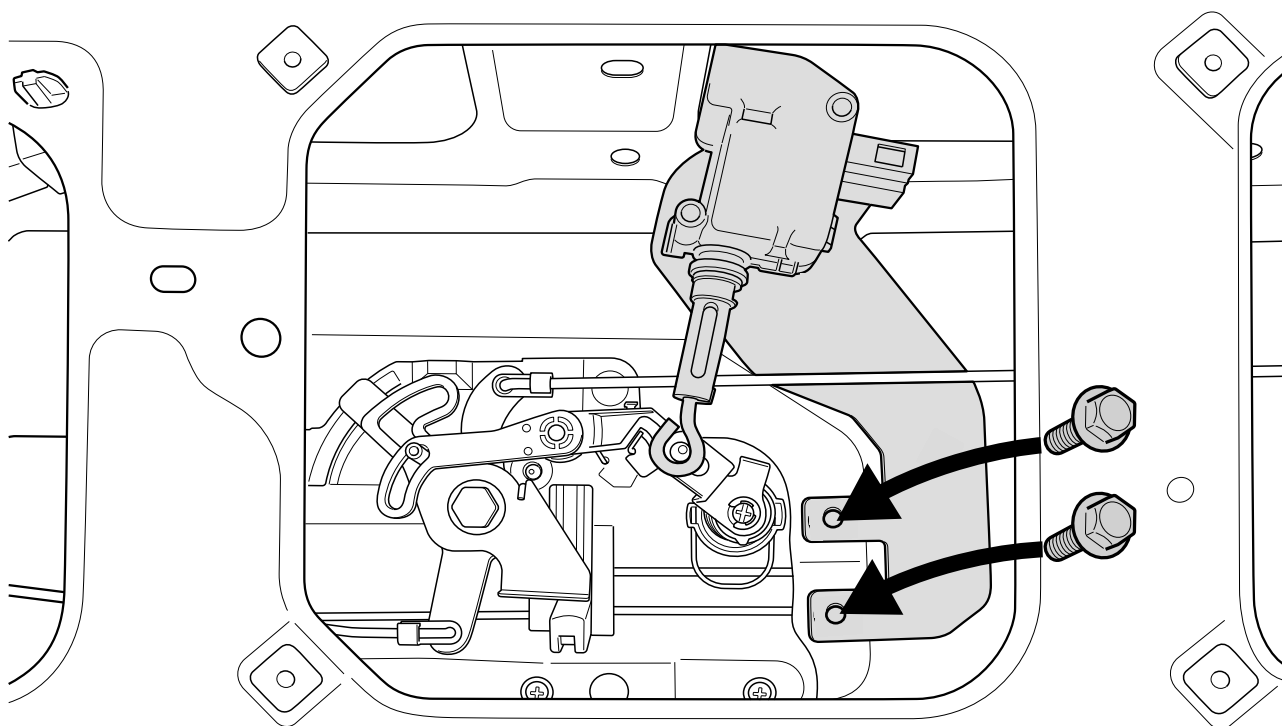
- 8 While maintaining alignment, fasten the bracket assembly into place using the retained factory M6 bolts, tightening them to the manufacturer's recommended torque specification.

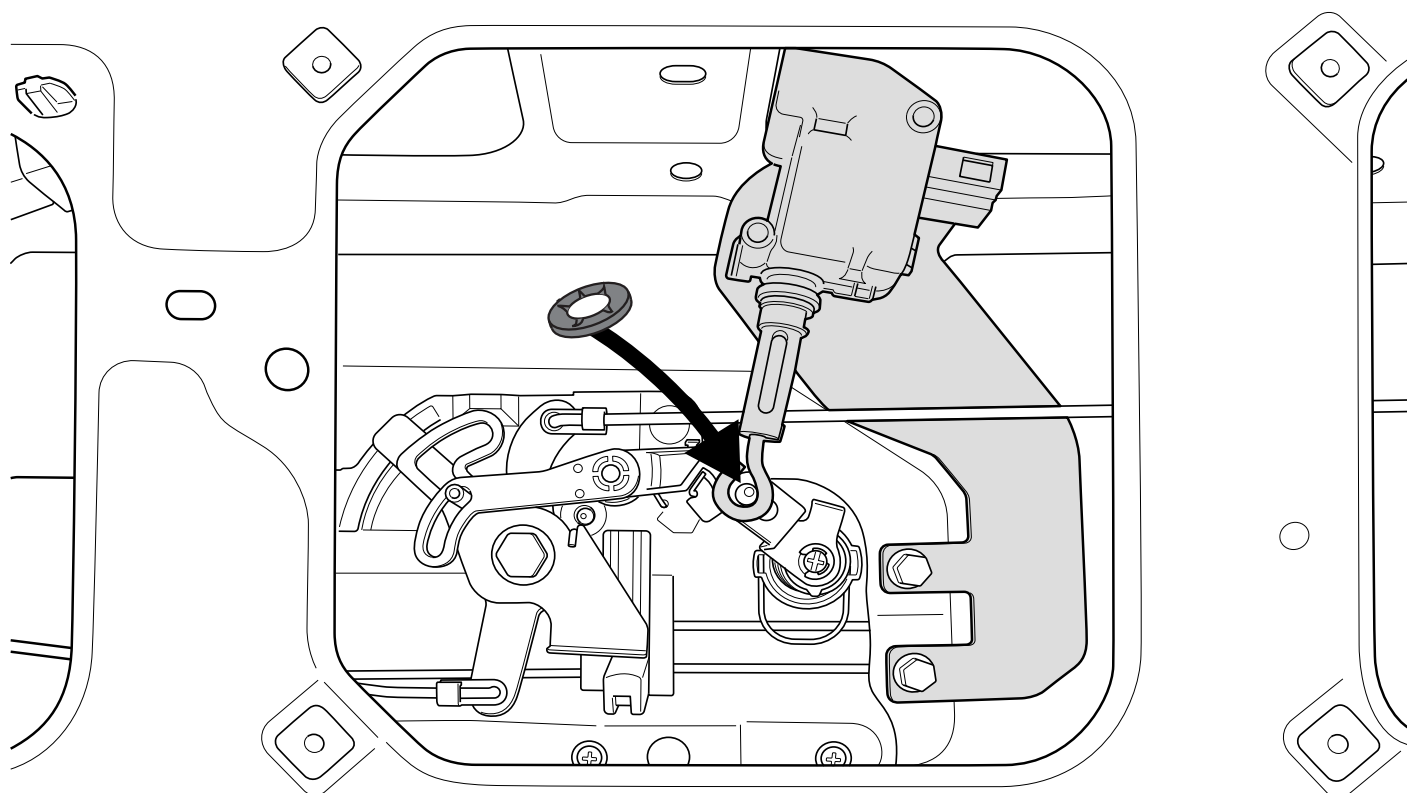
- 9 Fit the push-on clip over the indicated nipple as shown. Ensure the clip is pressed downward so it locks the eyelet in place and prevents it from disengaging.

*This step is critical.*

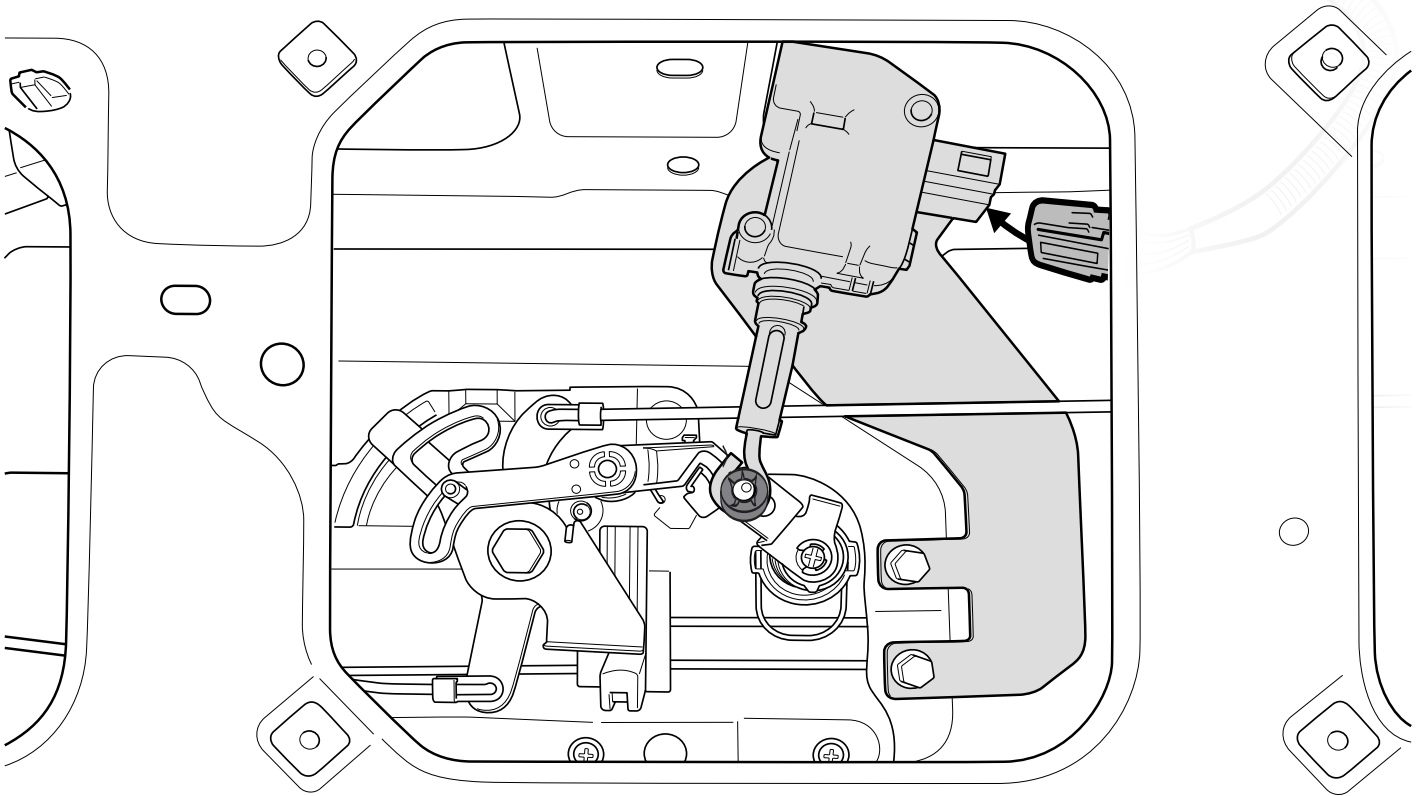
- 10** Connect the 2-way connector of the CL-LOOM-LONG to the actuator.

*Test the locking system by pressing the lock and unlock buttons on the factory key fob, then check the tailgate handle to ensure the system is operating correctly.*

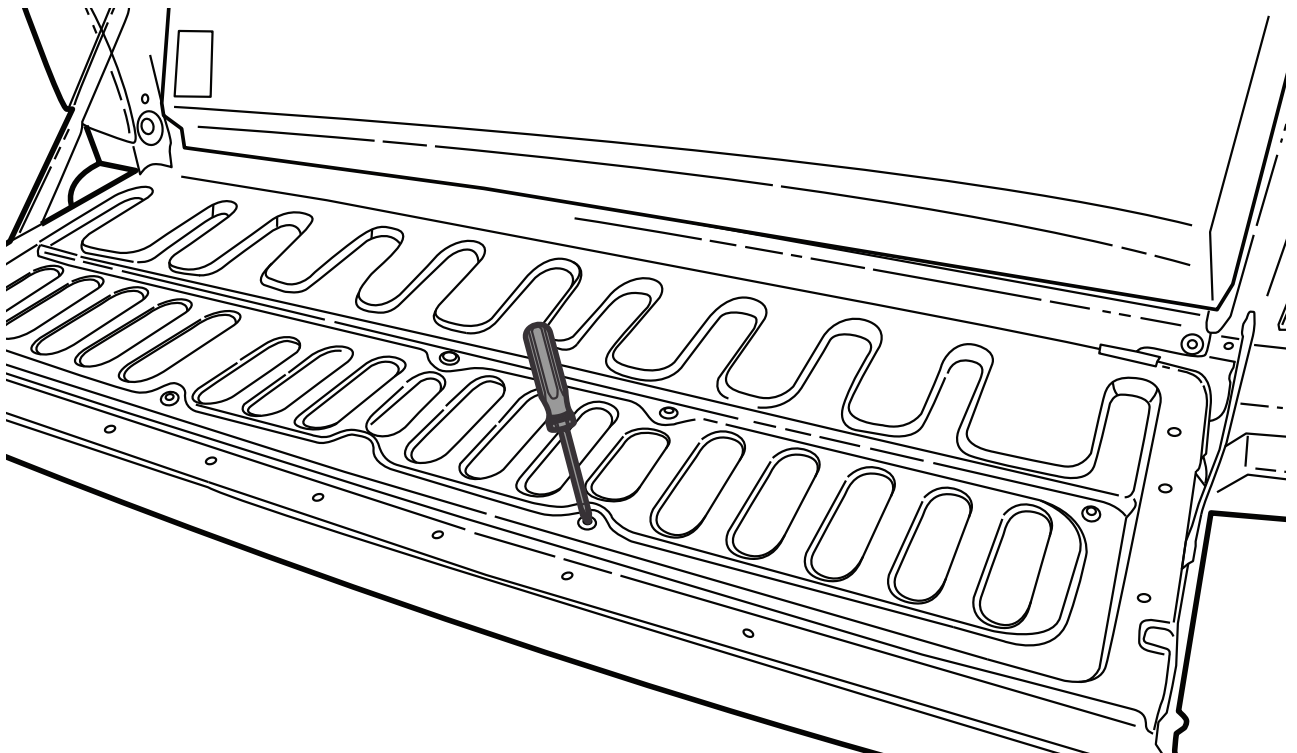
- 11** Re-fasten the tailgate cover using the retained factory hardware.
