# CASE STUDY

## Optimising Conveyor System Performance

A new 1200BW belt cleaner system was installed on Tuesday 10th January at Mount Thorley South CHPP. The new system replaced an old Primary H cleaner that was mounted on and bolted directly to the head pulley bearing assembly, and a secondary U cleaner with a pressure roller that was mounted in a fixed position under the belt return behind the head pulley.

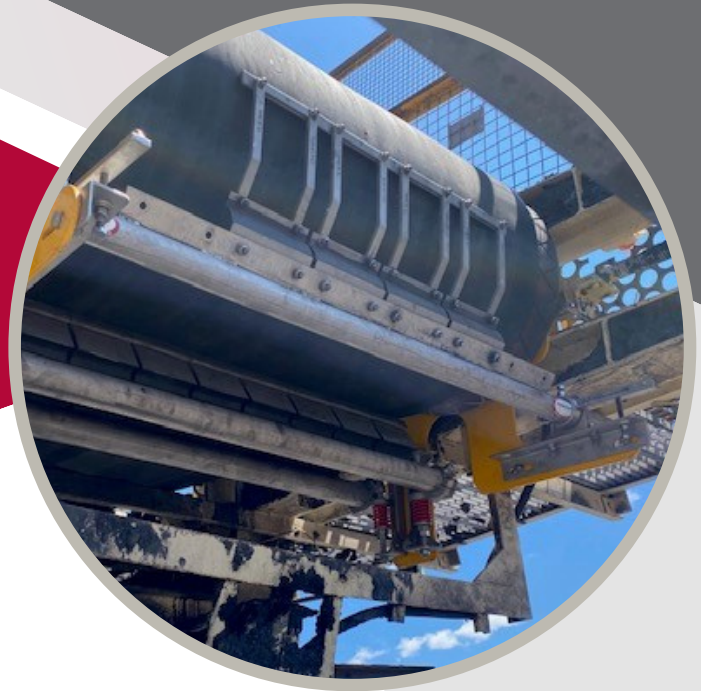
The new belt cleaner system is mounted on cheek plates that are supported on a track around the head pulley bearings. This arrangement transmits load directly onto the conveyor structure without putting a load on the pulley bearing housing, as the old system did. This allows the cheek plates to move with the pulley whenever belt adjustments are made, ensuring the primary cleaner maintains the correct coordinates and tension.

The outside tips and cushions were removed from the primary cleaner due to heavy belt wear and profiling conditions. This was done to provide better tip tension and cleaning until the belt is replaced later in the year. The secondary U cleaner was replaced with 2 spring-tensioned P cleaners that cover the full belt width and mount onto the cheek plates. Both P cleaners had their tips profiled to the worn belt for maximum performance.
