Case Study: Using a Passive Anti-Jam Antenna to Combat GNSS Interference

April 30, 2018

By John Fischer, VP, Advanced R&D

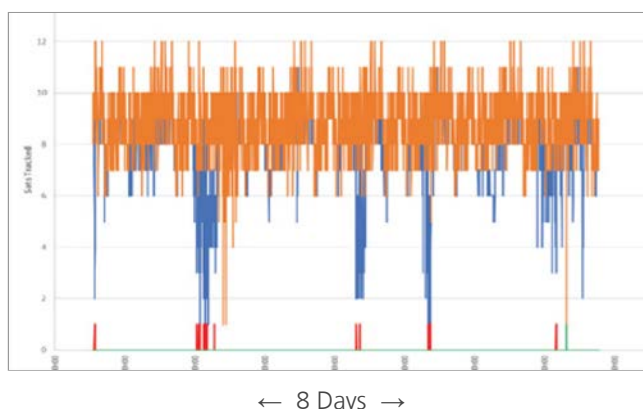
AJ Timing antenna: Field Test Data

Spectracom time servers have “Holdover” oscillators in them – atomic clocks that continue to maintain very accurate time even when GNSS is absent. However, no matter how accurate one’s internal clock is, it is still slightly different from the referenced Universal Coordinated Time (UTC) supplying the GNSS signals. So eventually time will drift from UTC. We refer to the period when the GNSS signal is lost and the time server is coasting on its internal atomic clock as a “Holdover Event.” The following chart shows the performance comparison between the two co-located time servers over a period of eight days, with blue for the standard antenna and orange for the AJ antenna.

- Two GNSS Time Servers with internal Rb Holdover oscillators: side by side, one with Standard Antenna; the other with AJ Antenna. Experiencing suspected “Privacy Jammer” interference – next to a trucking company.
- AJ Antenna drastically reduced GNSS dropout (Holdover Events) over a one week period.

Standard Antenna	AJ Conical Antenna
Holdover events	40	4
Total time in Holdover	1 hour 32 minutes	41 seconds
Longest holdover event	14 minutes 26 seconds	17 seconds
Average holdover event	2 minutes 18 seconds	10 seconds
Satellite alarms	31	2

The AJ antenna proved that the signal loss the customer was experiencing was a result of RF interference. As suspected, a nearby trucking company was being visited by trucks containing very illegal “privacy jammers” that interfered with GNSS reception. The AJ Antenna masked most of the RF energy coming from 20 degrees elevation and below, thereby mitigating the impact of illegal RF jammers.
